# The Hoof Redevelopment Center

A Division of Horses In Symmetry Farrier Services

**Martin D. Kenny C.J.F.**

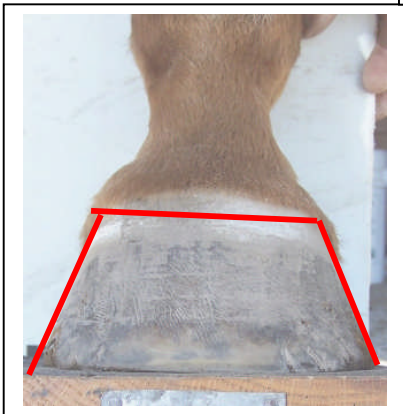
L/F foot

Lots of redevelopment still needs done but you can see that blue lines are showing a much closer match to the axis of the foot and pastern angles.

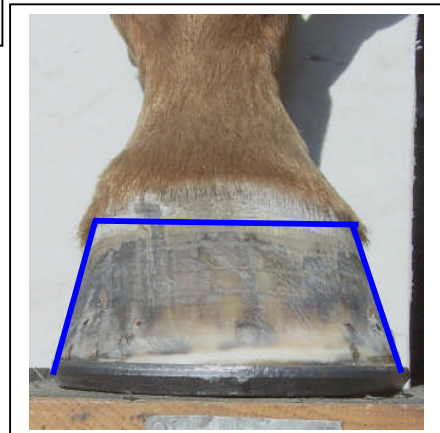
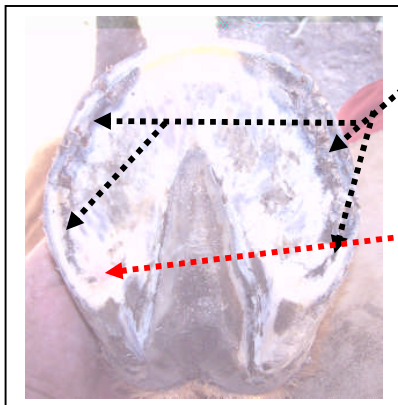
Blue lines showing less flare to the foot, which will translate to less tearing at the "white line" and provide a much more stable structure better able to support horse.

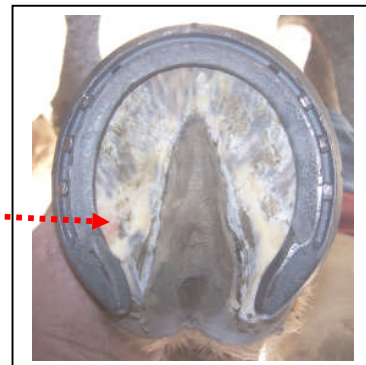
Blackened areas

and red spots indicate loading problems that we need to address.

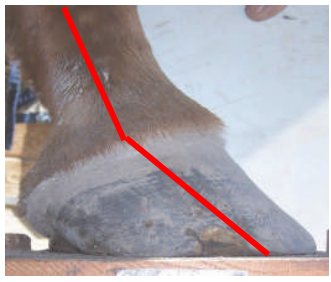
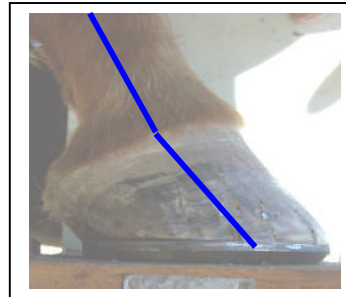
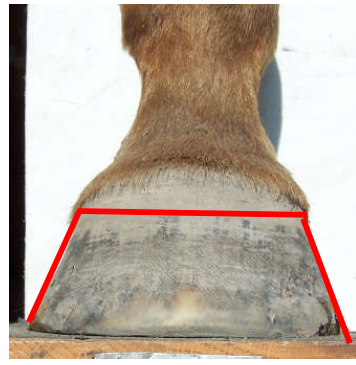
### R/F foot

Lots of redevelopment still needs done but you can see that blue lines are showing a much closer match to the axis of the foot and pastern angles.

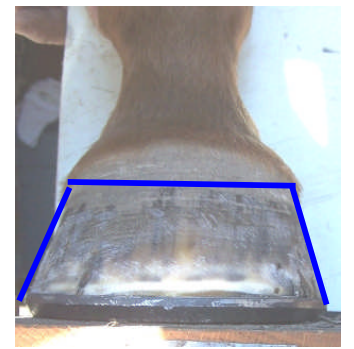
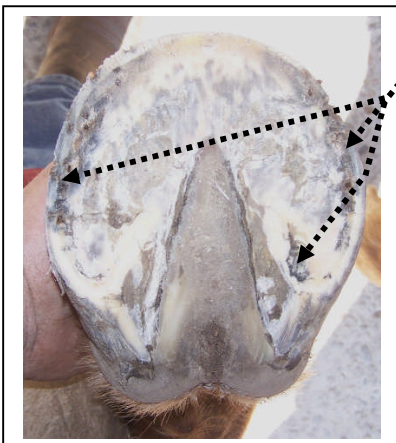
Blue lines showing less flare to the foot, which will translate to less tearing at the "white line" and provide a much more stable structure better able to support horse

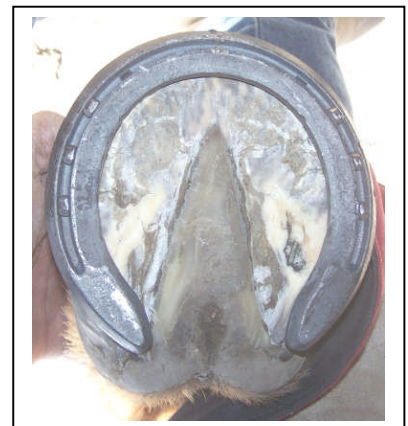
Blackened areas are areas that are indicating load issues that we need to address over time.

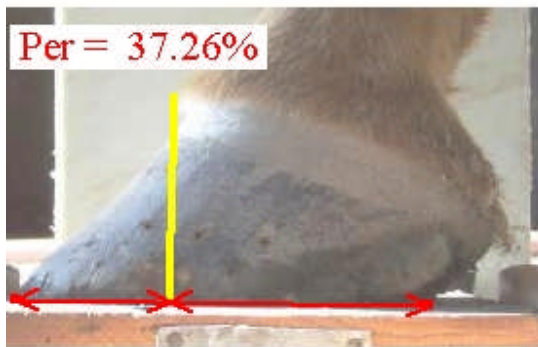
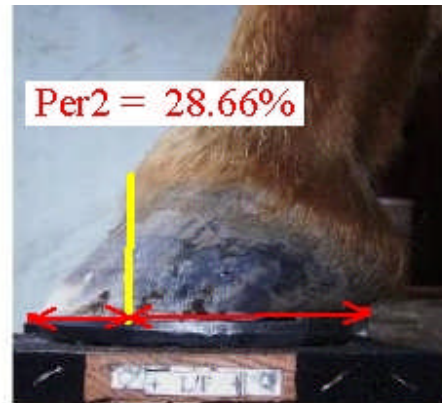
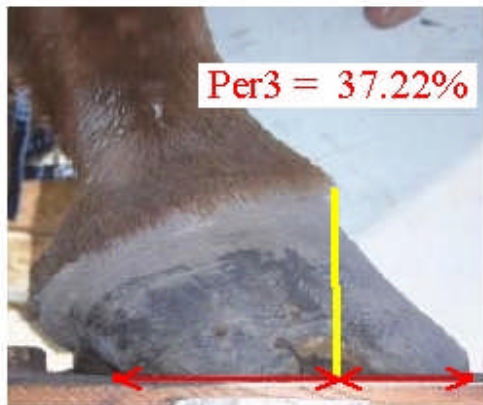
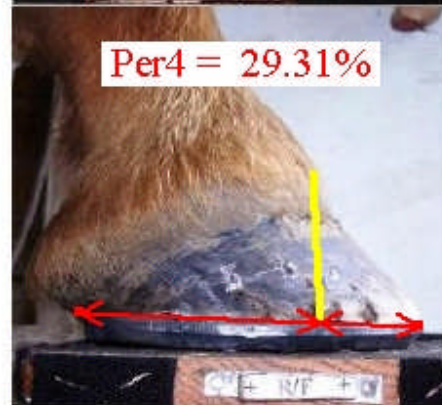
The photos above were taken on 1.30.07 pre trimming. The Percentage of foot ahead of the dorsal aspect of coronet band region is excessive (ideal should be in range of 25% or so) and may cause this horse to stumble.

This foot configuration would also create a flatter, thin sole region, making the foot susceptible to stone bruising and sensitivity.

Note the curved downward sloping bulbs of these heels. This crushes the digital cushion, inhibiting blood flow to the hoof capsule.

The photos above were taken 4.11.07 post shoeing (10 weeks later) and you can see that the percentage of foot ahead of dorsal aspect of coronet band is greatly reduced. This is not done by simply rasping away the toe region as to do that would greatly weaken the toe region and further compromise the hoof capsule. It is accomplished by a very technical hoof care called "Symmetrical Hoofcare Protocol" (S.H.P.) Developed by Martin D. Kenny CJF.

As well, you can see that the heel bulbs are looking less stressed and show marked change in downward transition; allowing for less compression to digital cushion. The heel is showing improvement in angulation as well.

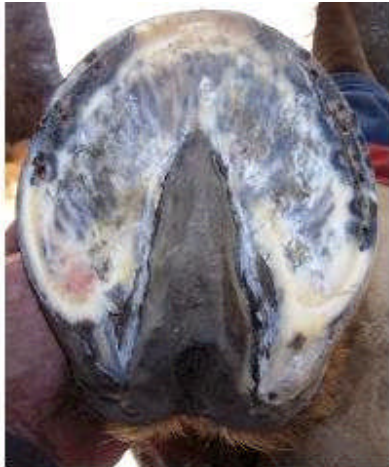
This photo is of Left Front foot on 1.30.2007 post trimming. You can see the trauma being created by the excessive heel loading. The crushing of the heels is substantial and is showing compression to the digital cushion as well by the way that the hoof capsule is further forward than the bulbs (softer portion) of the heels.

You can also see the non symmetrical shape of this foot indicating an oblique loading of the foot as well.

There should be NO BLACK areas along the “white Line” region of the foot. The black areas indicate tearing of tissue created by improper loading of the region.

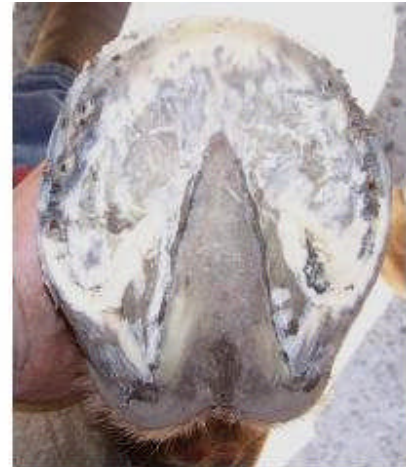
This is the Right Front taken on 1.30.2007 Post shoeing. You can see many of the same issues as with the L/F. You can also see tearing in the “Bar Region” of this foot as indicated by the blackened areas along the bars next to the frog.

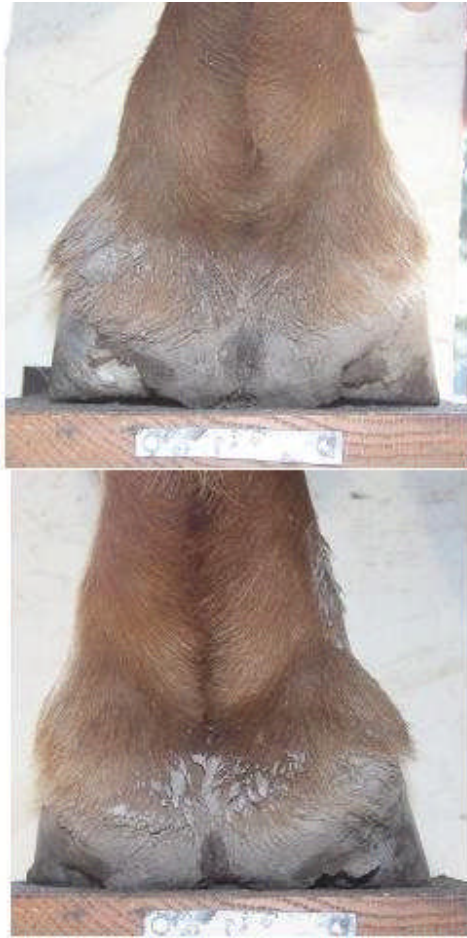
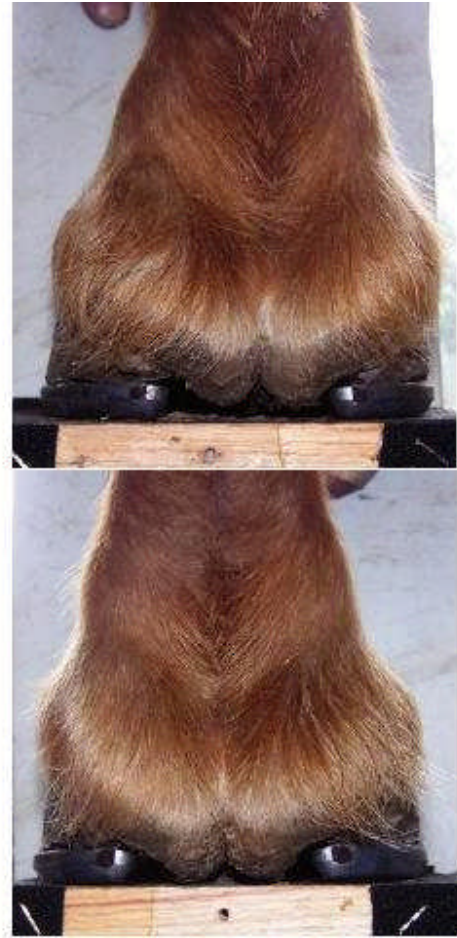
Top row is L/F Bottom is R/F Left is 1.30.2007 and Right is 4.11.2007

Note how both feet showed marked medial loading of the hoof capsule. The limb is entering the capsule to the medial (inside) of center line of foot. This is most noticeable in top

(left foot) photo. This further shows the oblique loading of the capsule as indicated on previous document.

Also note how the frog and bulb region is compressed providing for little room for the digital cushion inside. The frog is enveloping the heels of the hoof capsule. With this configuration there is no room for the bone column to descend upon impact without further crushing of the region.

Note that the limbs are more centered over the hoof capsule and that the frog and bulb region has less compression. This is imperative to have at this stance so that the bone column may properly descend upon impact. This configuration will provide the foot with the ability to better absorb impact without tearing and or compression of the tissue making up the hoof capsule.

Given time and a continuation of Symmetrical Hoofcare Protocol the heels of the foot would develop more depth as well as the frog itself.

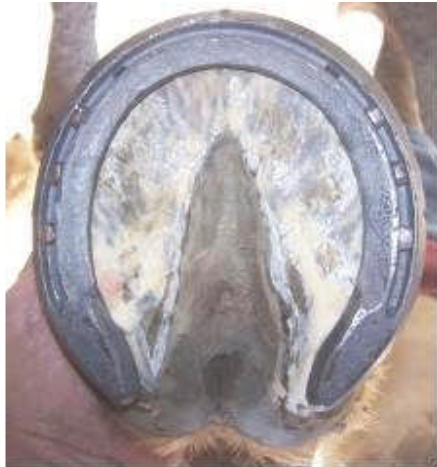
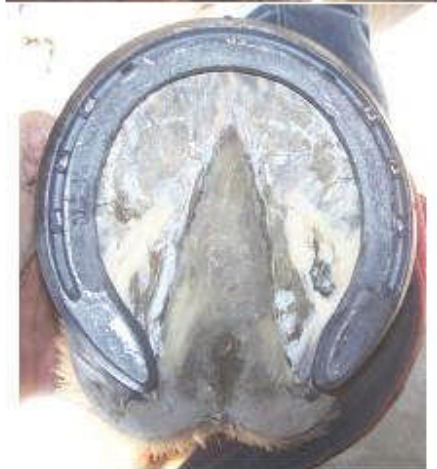
This row of photos is from initial shoeing on 1.30.2007. Top is L/F.

The 1.3.07 photos are overexposed but you should still be able to see that there is a compression of the frog area and the bulbs appear to be shoved rearward on the foot. You can also see the details noted on previous views, such as the black areas along bars in bottom photo and the "corn" in top photo.

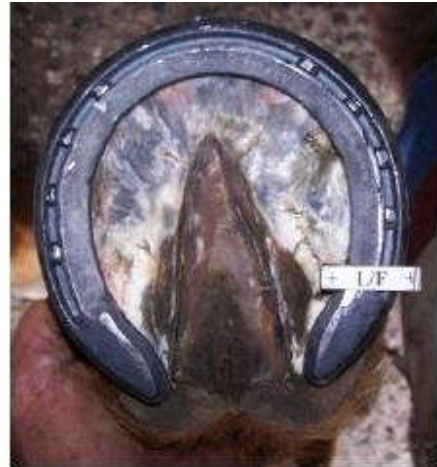
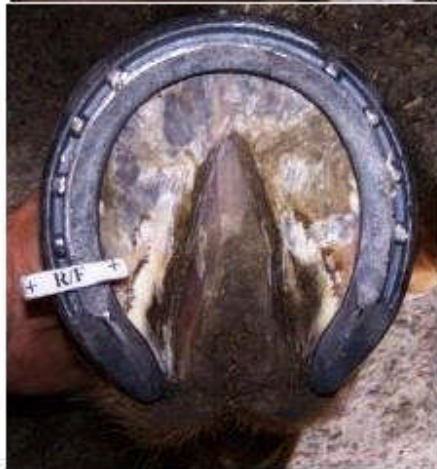
This row of photos is from 10 weeks later on 4.11.2007. Bottom is R/F.

The 4.11.07 shots show less compression of the frog areas and the other pathology growing out (such as black areas along bars in bottom photo and "corns" in top photo). It is hard to appreciate in photos but there is more concavity in sole as well. This type of foot has a lot of pathology that needs to be addressed. It takes a lot of time to do so. With SHP this can be achieved. Without it I am not certain that it can be changed; only maintained.
